Executive Summary

On October 10, 2006, Baltimore City Fire Fighter [FF] Allan Roberts, Fire Fighter/Paramedic Apprentice [FPA] Brandon Mattox, and FPA James Butler sustained injuries in the line of duty while battling a two-alarm fire located at 514 South Macon Street in Baltimore City. FPA Mattox and FPA Butler survived their injuries. Sadly however, FF Allan Roberts died as a result of his injuries.

As a result of this incident, Baltimore City Fire Chief William J. Goodwin Jr., appointed a reconstruction committee to investigate, evaluate, and make recommendations on the emergency response and activities conducted during and after this tragic event.

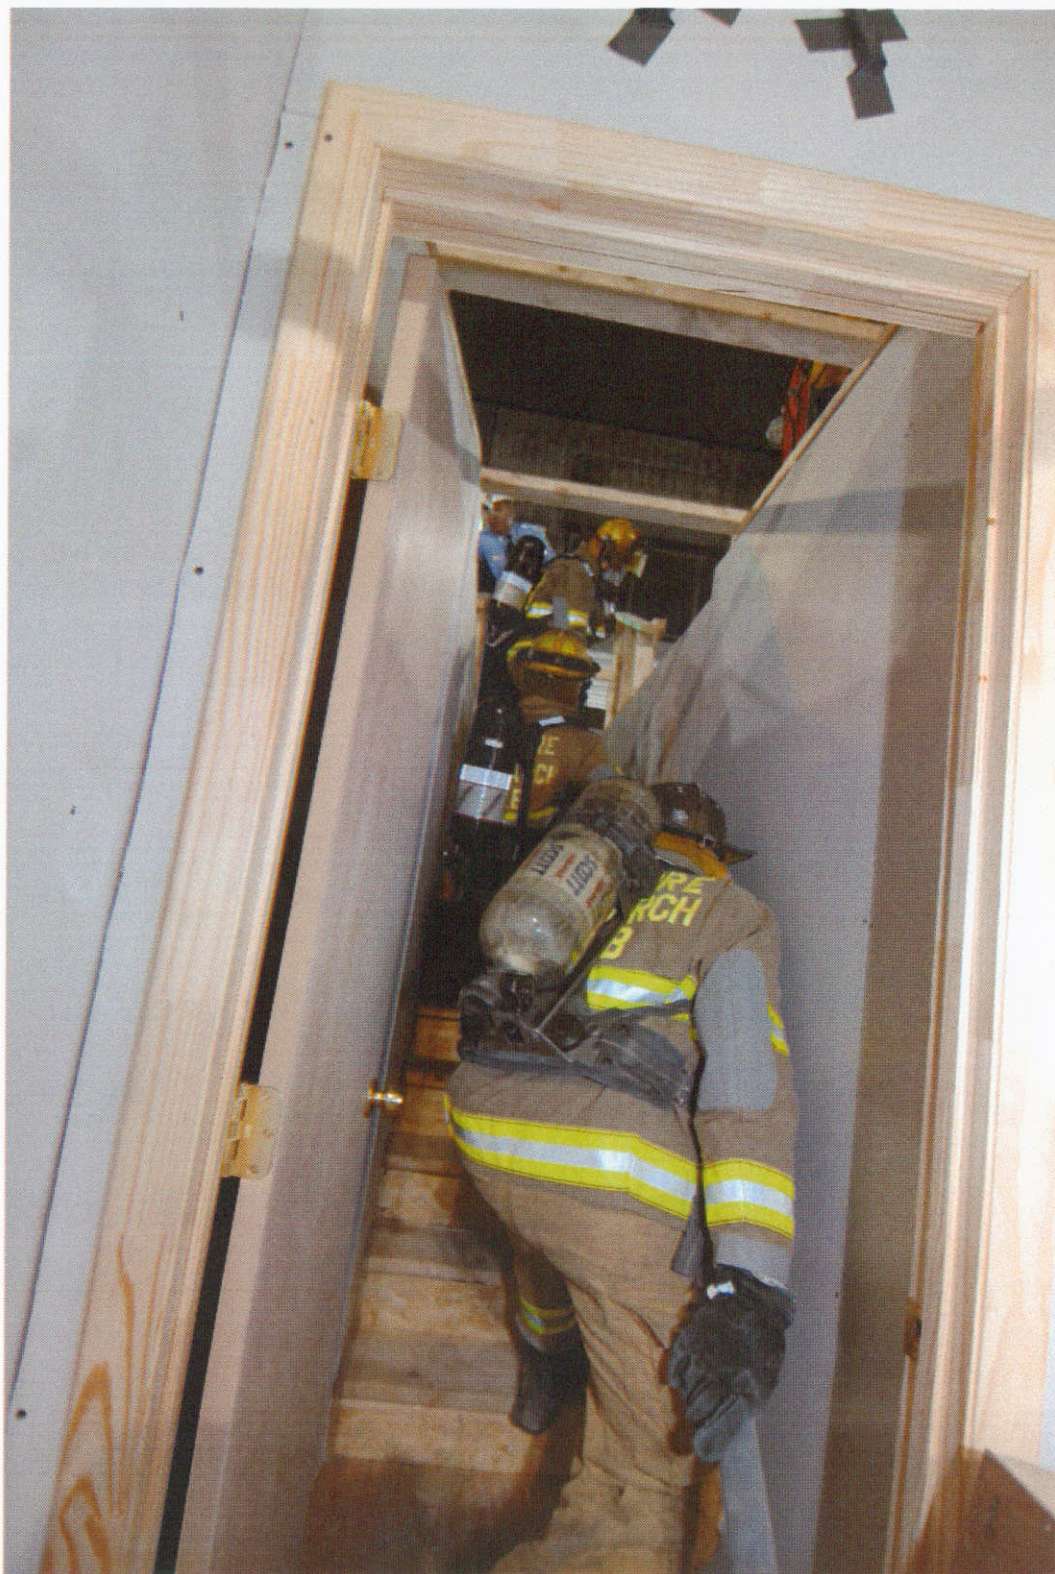
**Re-enactment photo showing the final position of members on the stairs.
This is as far as the members were able to advance.**

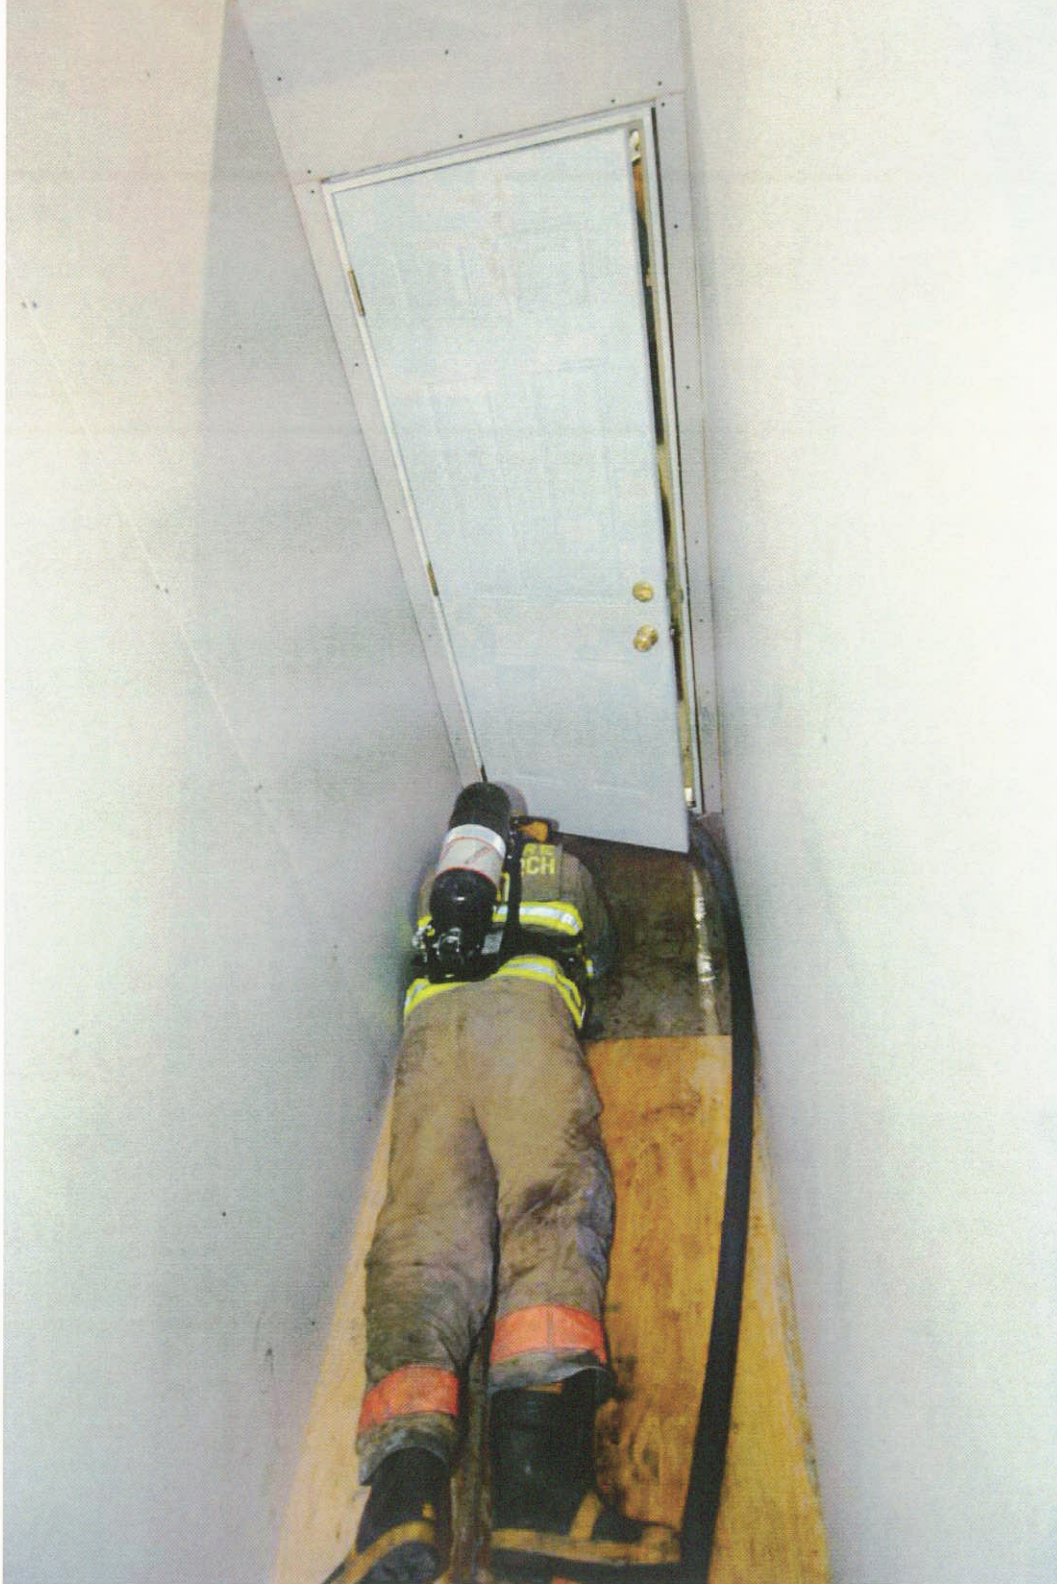
Re-enactment showing FF Roberts' position that prevented rescuers from opening the door. The door had to be removed in order to remove him from the dwelling.

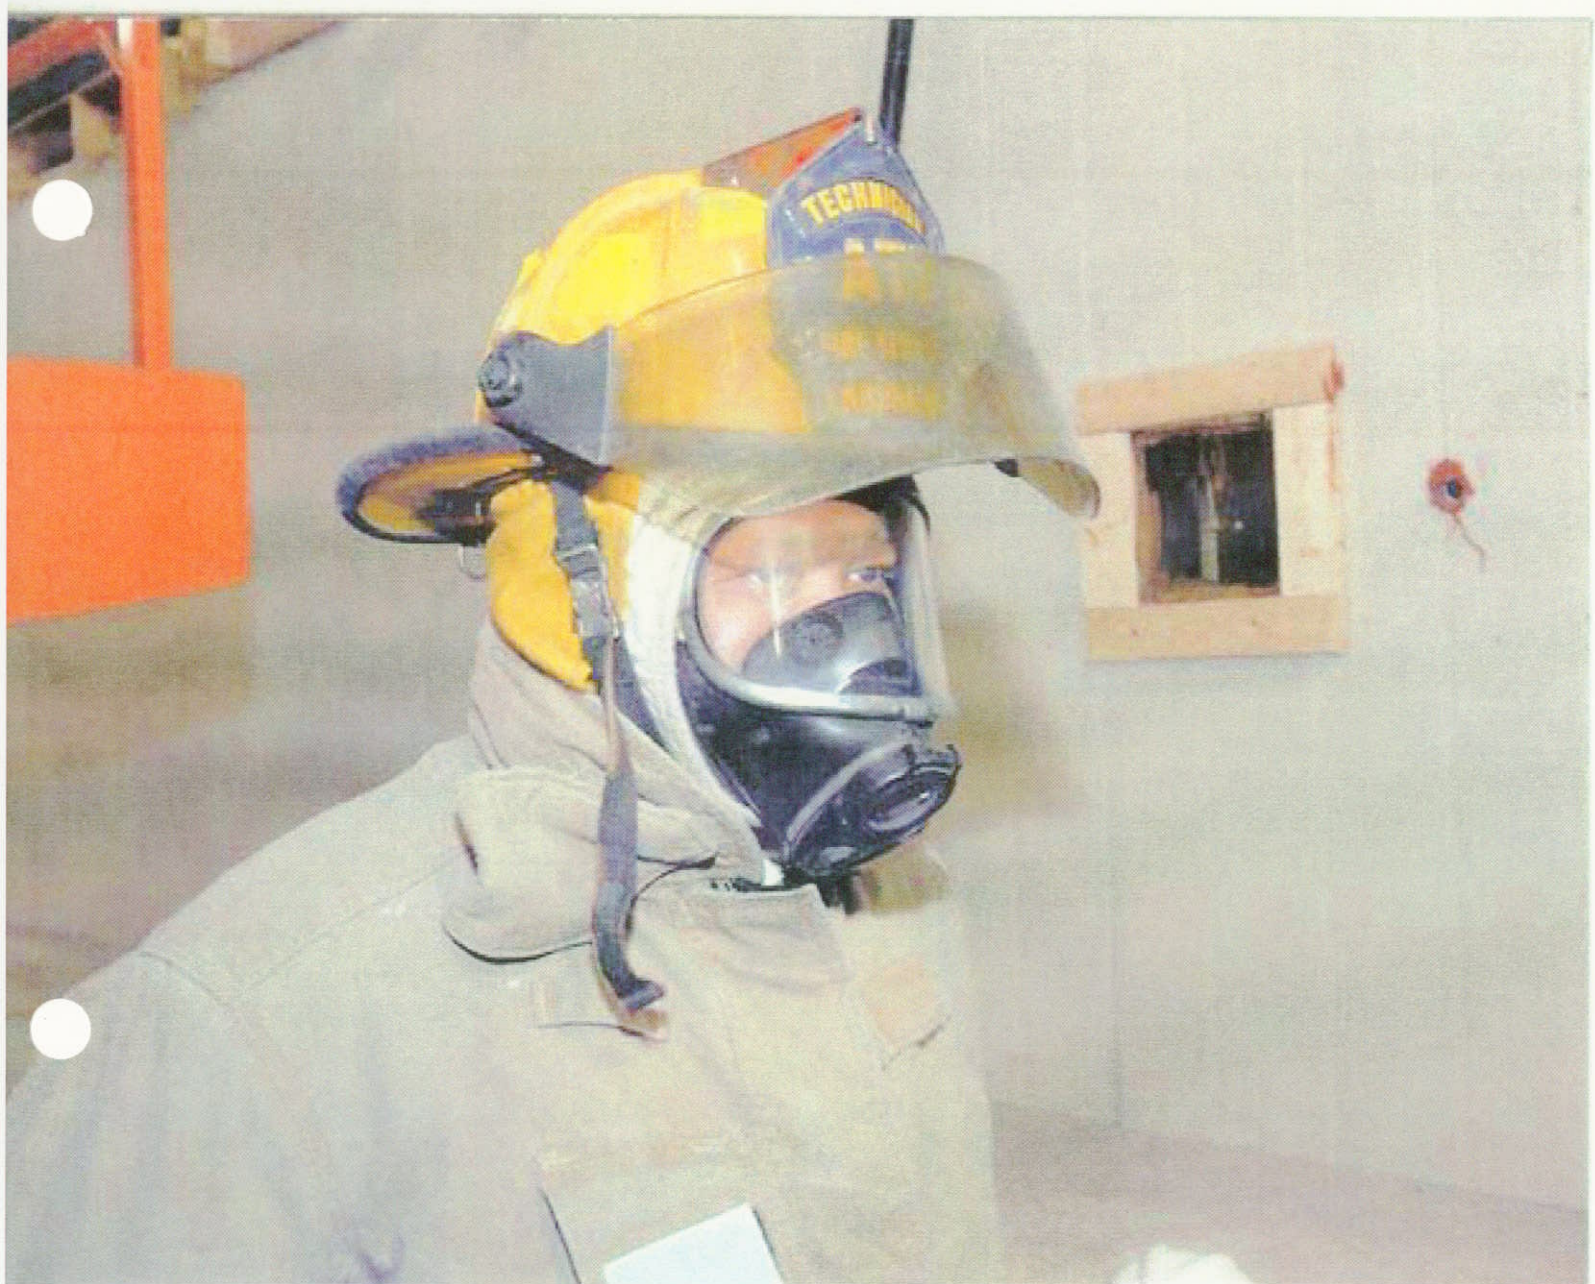
Re-enactment photo showing properly donned helmet, hood, and facepiece. The proper order for donning this equipment is facepiece, hood, and then the helmet.

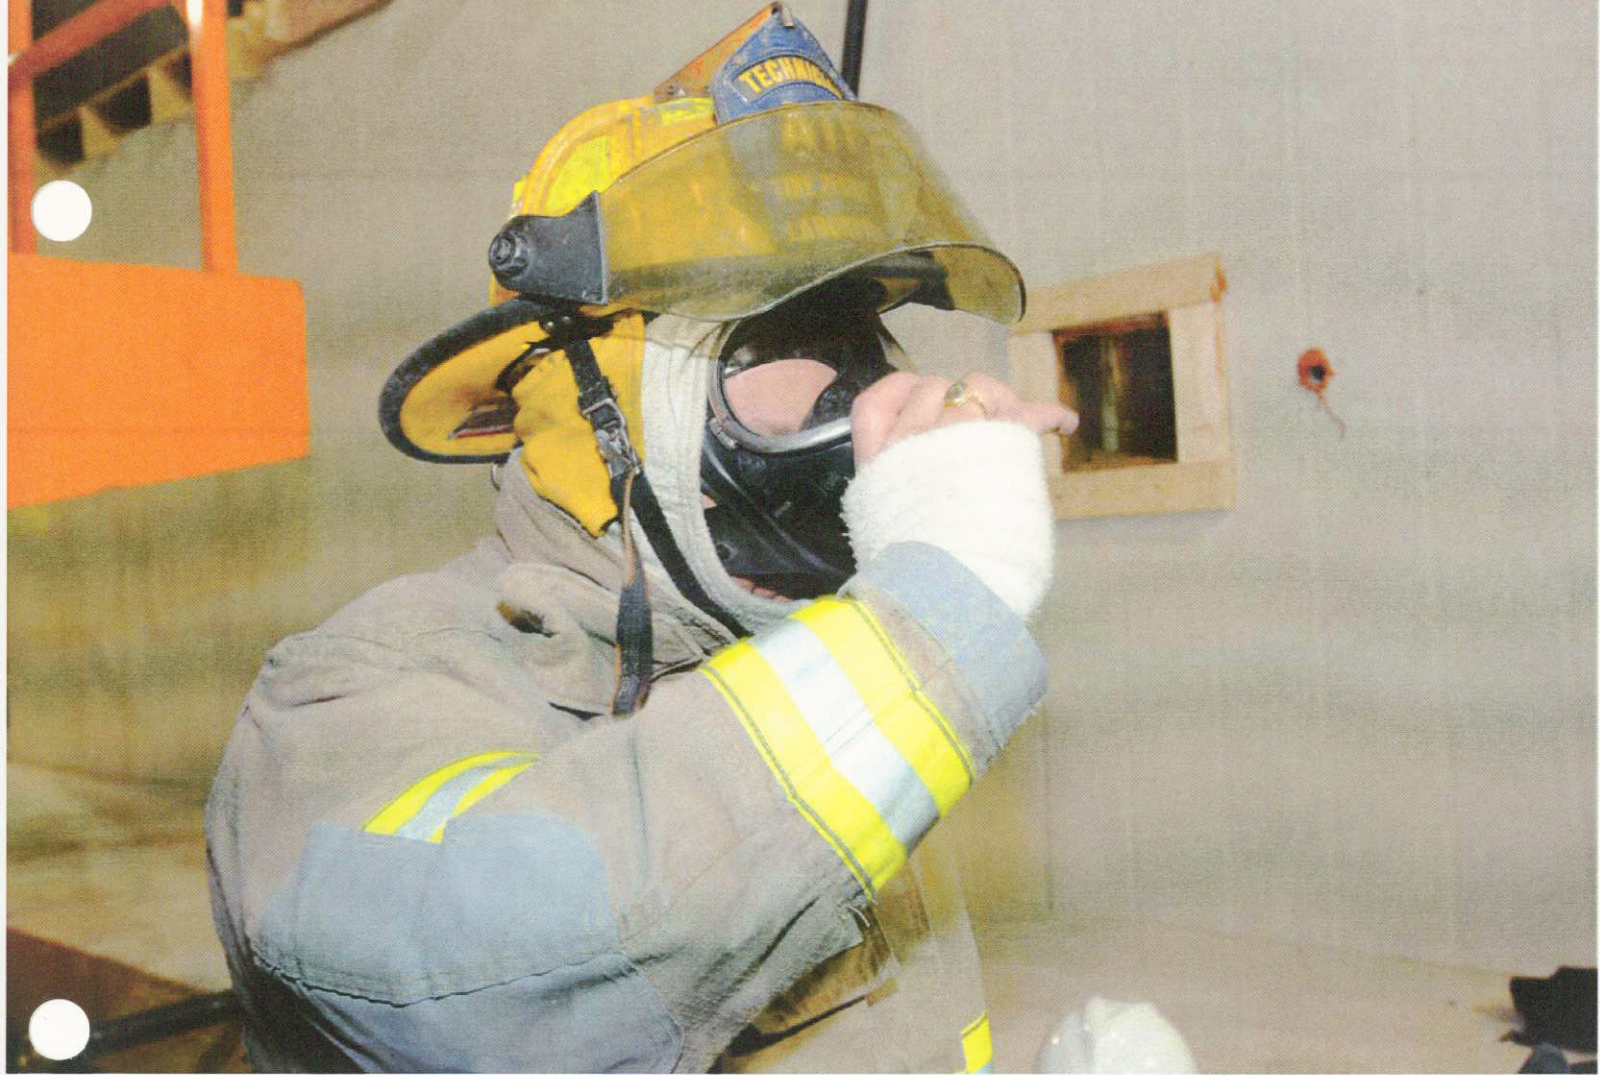
- c) During a re-creation of this scenario, it was not possible to remove the face piece when worn with a hood over the face piece and helmet in place.
[See photos on ensuing pages]

Re-enactment photo showing the difficulties encountered when trying to remove the facepiece when it is properly donned with hood(hood worn over facepiece)and helmet .

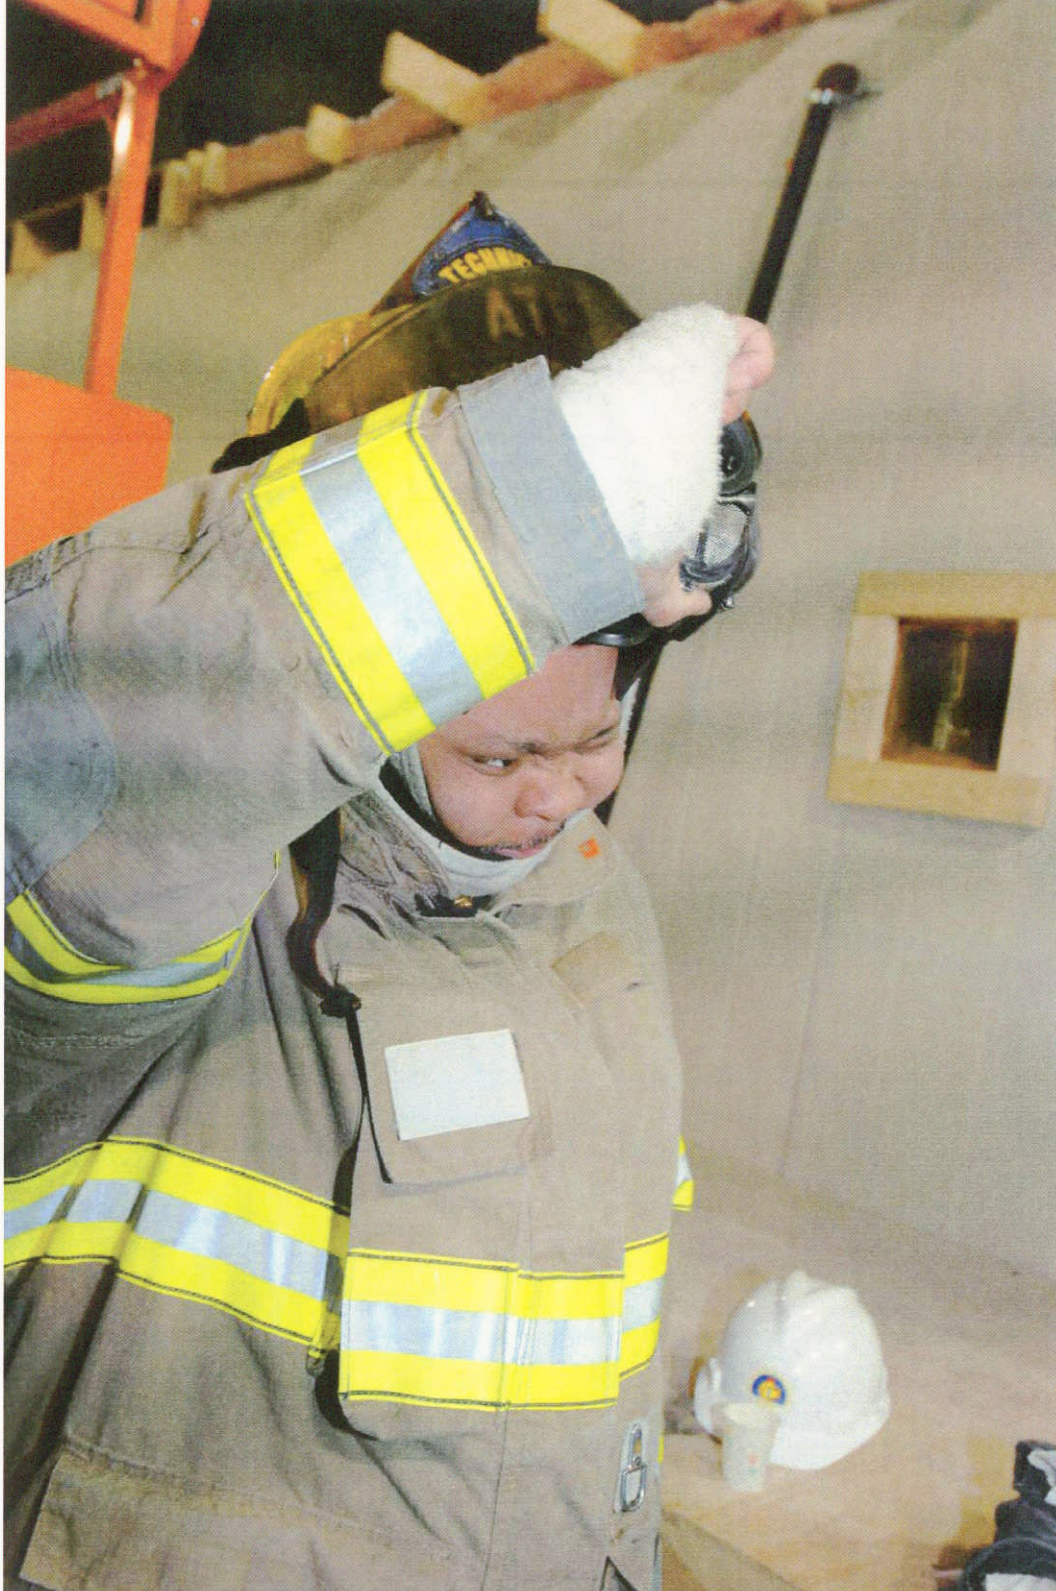
- 1) All indications are that FF Roberts was **not** wearing a hood when he entered the dwelling. The following items were considered when arriving at this conclusion:
 - a) The thermal injuries on his face and head indicate the lack of a hood at the time the burns were received.
 - b) No hood was ever recovered at the scene.

Re-enactment photo showing the ease in which the facepiece can be removed when not worn properly. This photos depicts the improper donning of the facepiece over the hood.

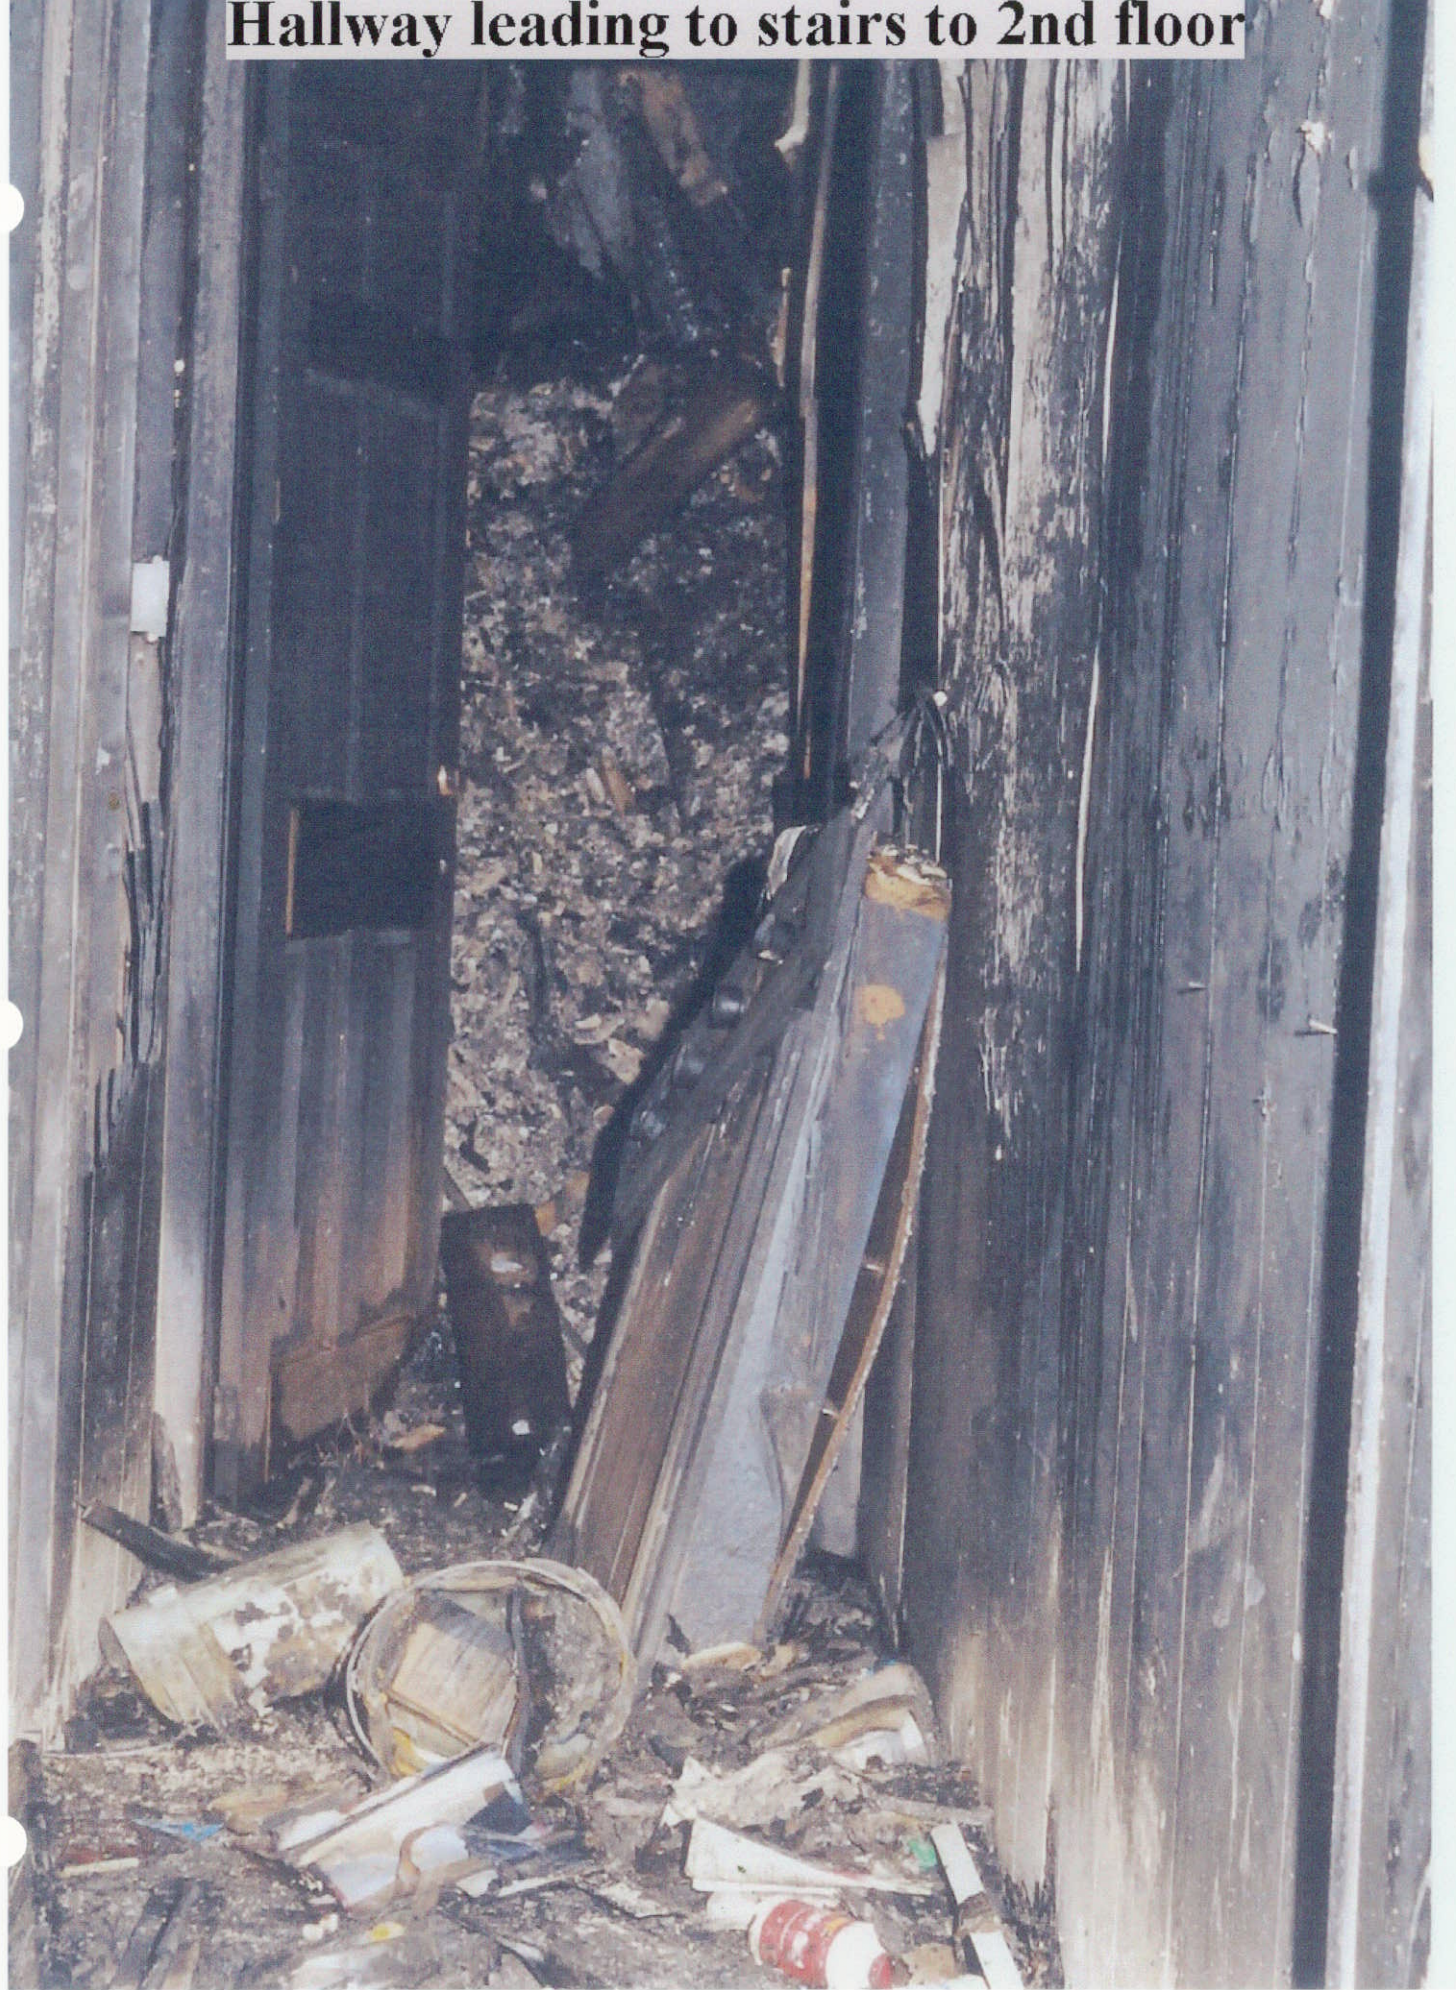
Area of origin (basement)

It is believed the above-mentioned remodeling greatly contributed to the fuel load [thin laminated paneling], the rapid vertical extension of the fire [large open voids behind the walls and ceilings], and the early collapse of the first and second floors, along with the roof area [exposed joist with previous fire damage]. [See figures 4, 5 and 6 on the following pages].

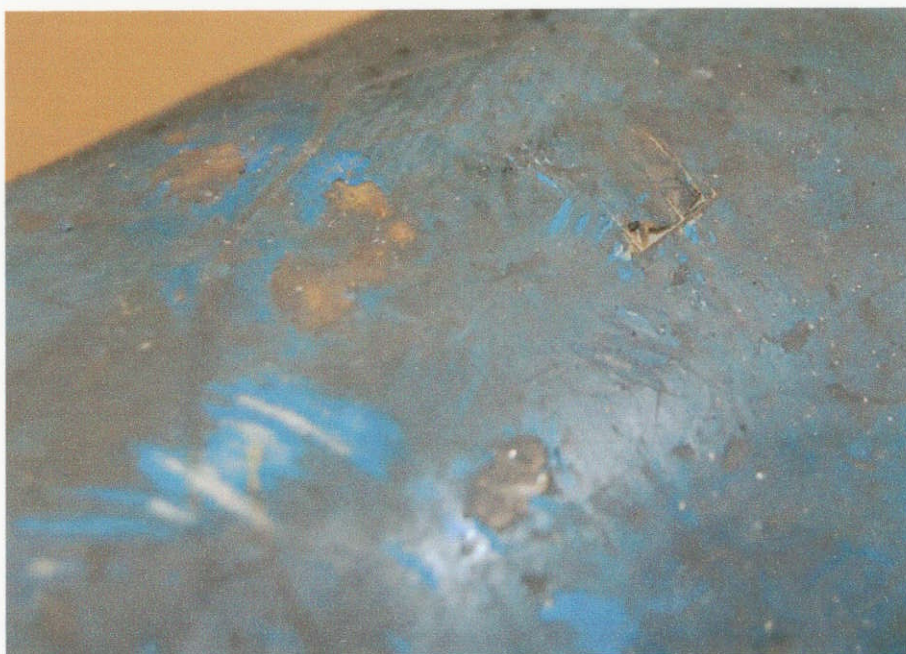
Figure 23 – Damage to Cylinder Composite Layer

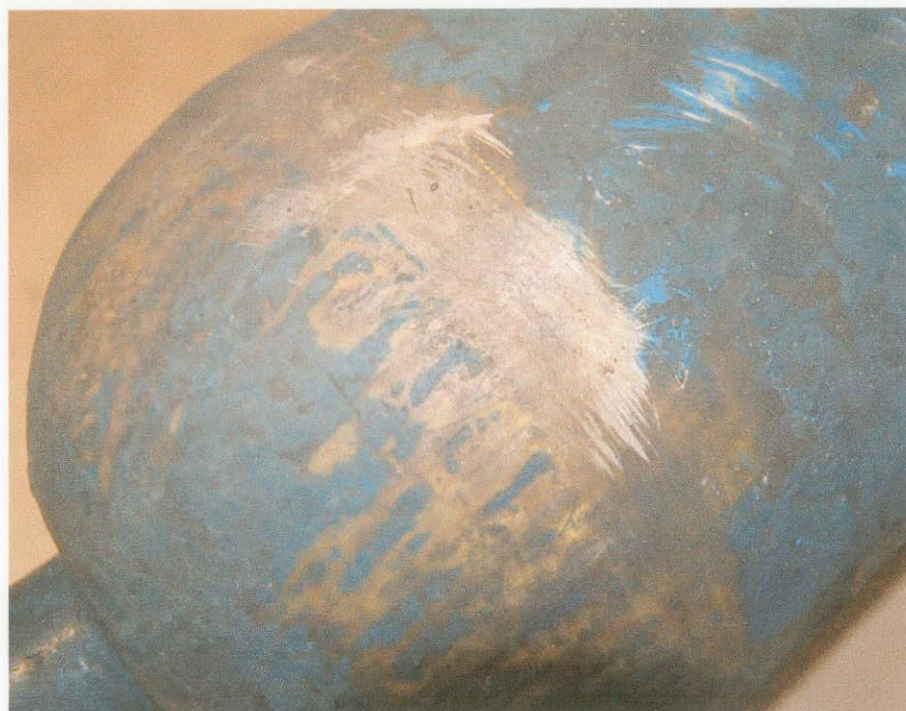
Figure 24 – Damage to Cylinder Composite Layer

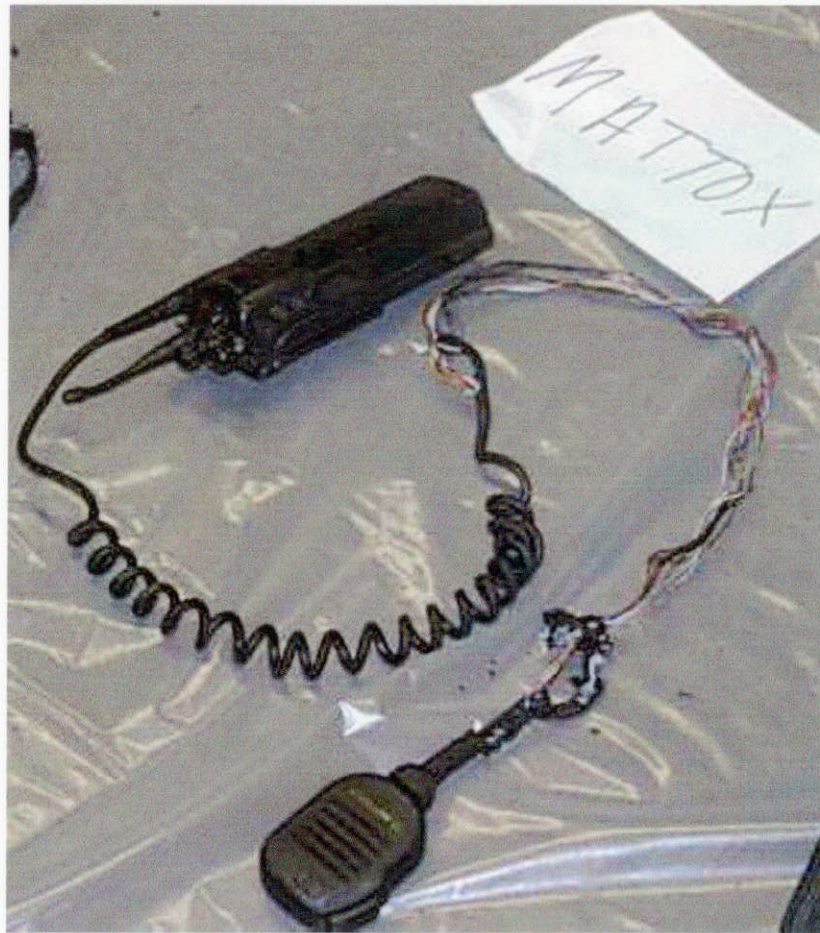
This photo shows the condition of Mattox's portable radio. The wires to the remote microphone received heat damage.

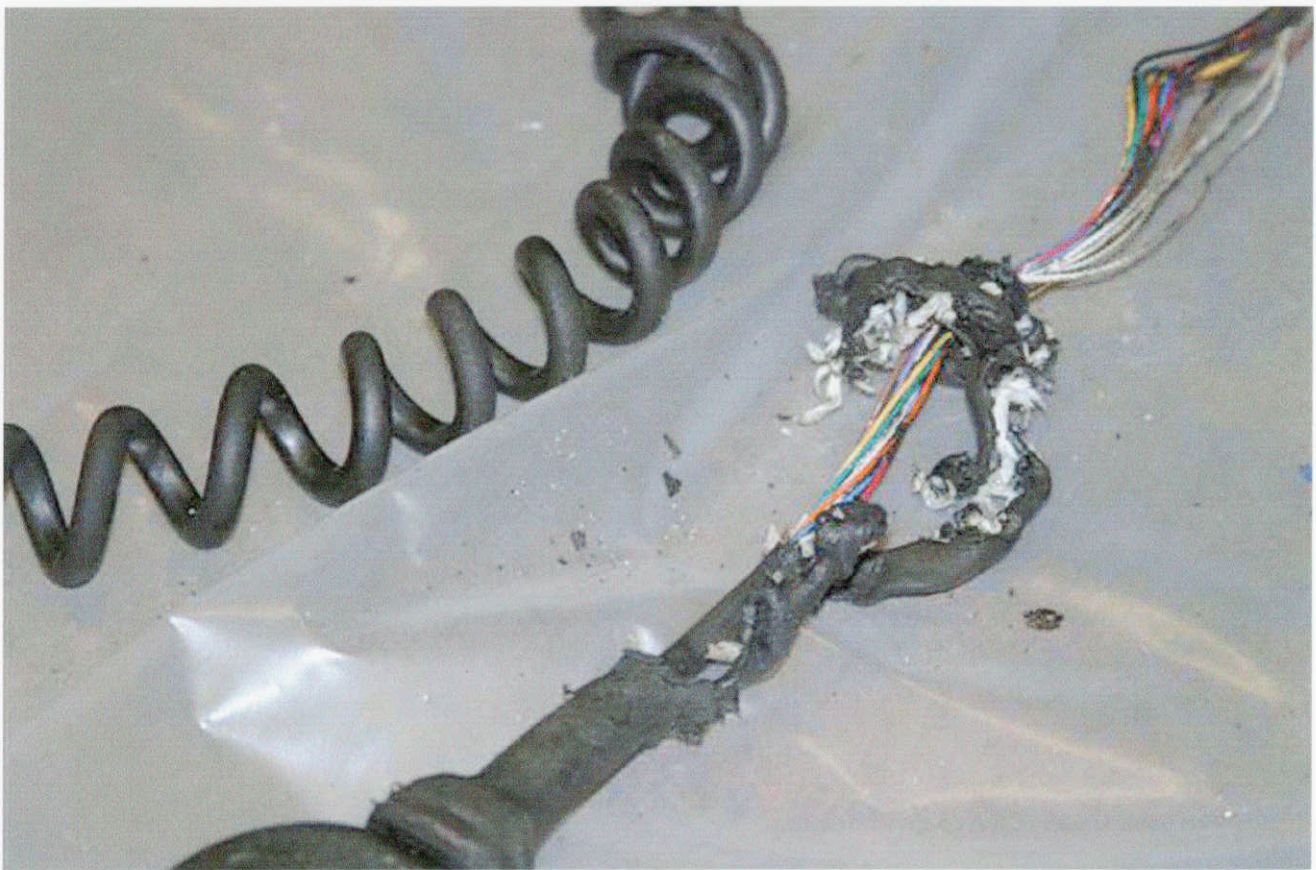
This is a close-up view of the damage to Mattox's portable radio caused by the excessive heat.

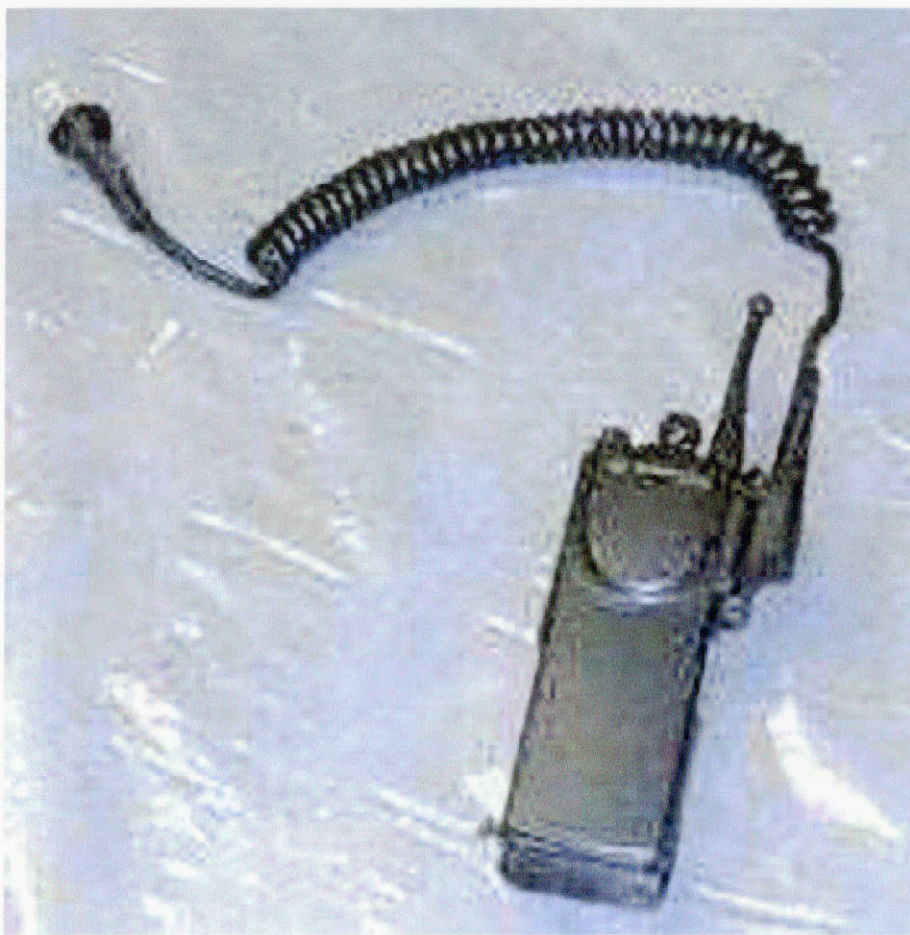
This photo shows the condition of Butler's portable radio. The remote microphone is missing because it was damaged and lost as a result of the heat encountered by FPA Butler.
